RECREATION AVIATION ADMINISTRATION SOUTH AFRICA	RAASA Postnet Suite #118 Private Bag X1037 Germiston 1400
Telephone No: 011 827 9330 Facsimile No: 011 824 3517 Cell phone No: 076 875 4722 Email: info@raasa.co.za Web: www.raasa.co.za	Recreation Aviation Circular	RAC A02/09

Service Bulletin

Cheetah Aircraft elevator control stick hinge bolt inspection.

IMPORTANCE Before next flight
AREA AFFECTED Flight controls
SB SERIAL NUMBER Cheetah/001/09-2009

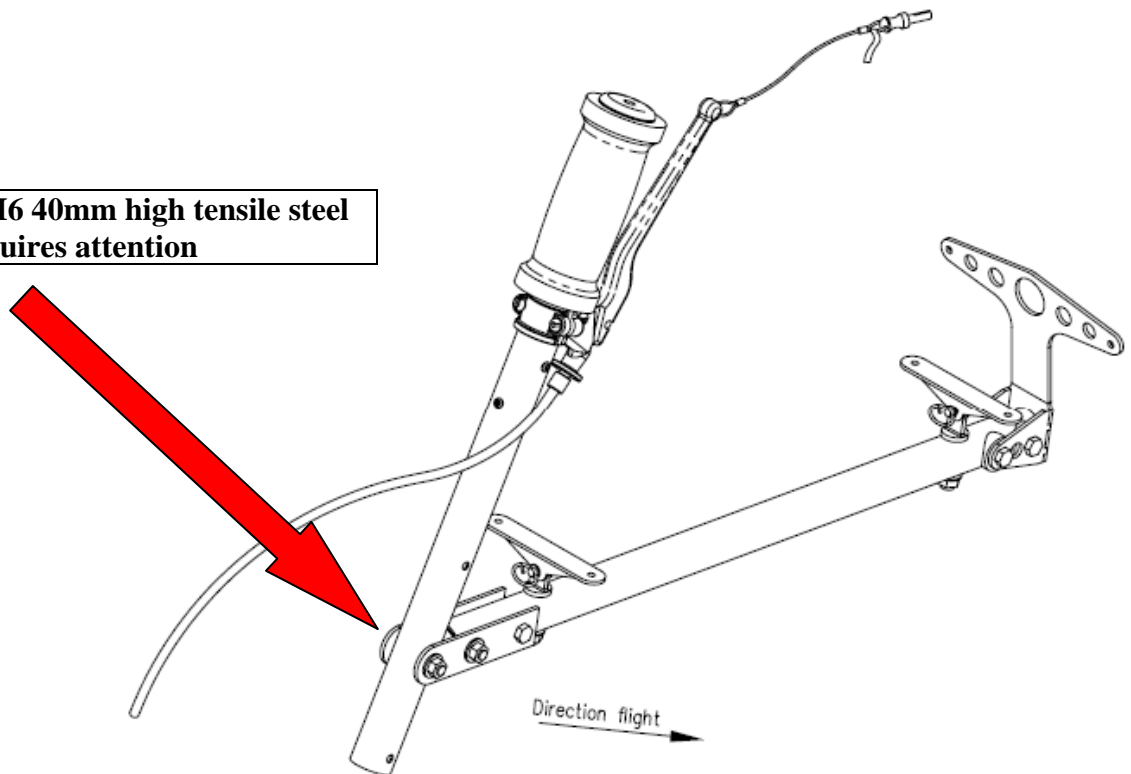
Failure of this part will cause loss of pitch control and failure of control of the Aircraft

This is the M6 40mm high tensile steel bolt that requires attention

Rainbow Aircraft has recently conducted a 500 Hour inspection on a Cheetah XLS. During the process of replacing an Elevator cable, it was found that the Elevator / Aileron control stick in the flight deck had a small amount of play. On further investigation it was found that the M6 40mm 8.8 high tensile steel bolt used as the pivoting point for elevator control, has worn away to allow play to form. The bolt has been inspected to determine the severity of the defect. The bolt has been found to have eroded away due to friction. This friction is induced by the cable tension from the elevator cables. **This situation is normal**

Immediate compliance: Inspect the Elevator control stick, hinge bolt for erosion (wear) as per accomplishment procedures.

Long term compliance: Replace this hinge bolt every 500 hours.

If there are any defects the bolt must be replaced. (See replacement parts)
